Investigation of creep slip of a fracture in Callovo-Oxfordian claystone with Digital Image Correlation

Sophie Jung

CIGEO (Centre Industriel de Stockage Géologique / Industrial center for geological disposal) project

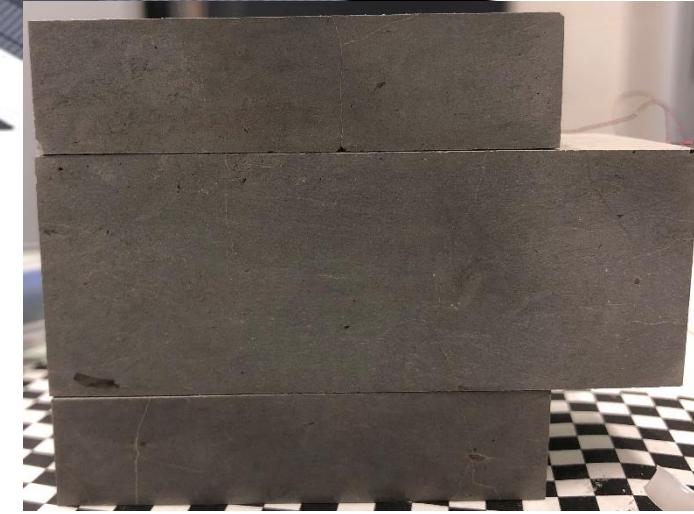
Experimental Setup

Methods :

Cut the block in the Core

Polish 3 faces for the DIC

Polish 4 faces for achieving a proper roughness of the sheared faces

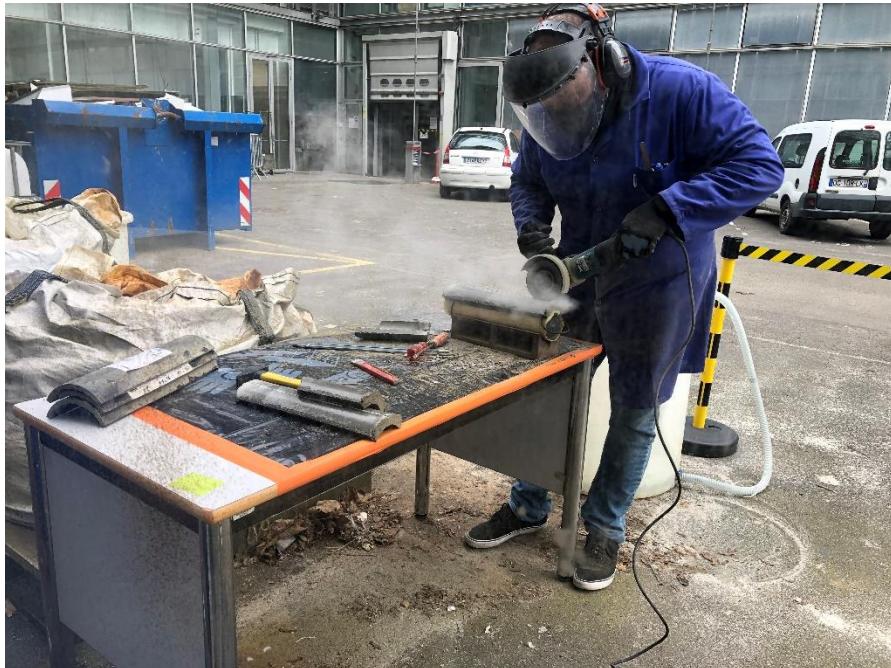
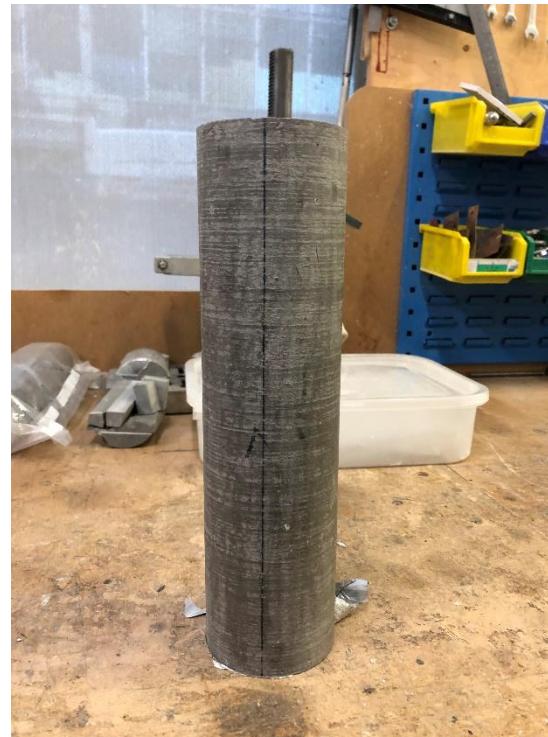
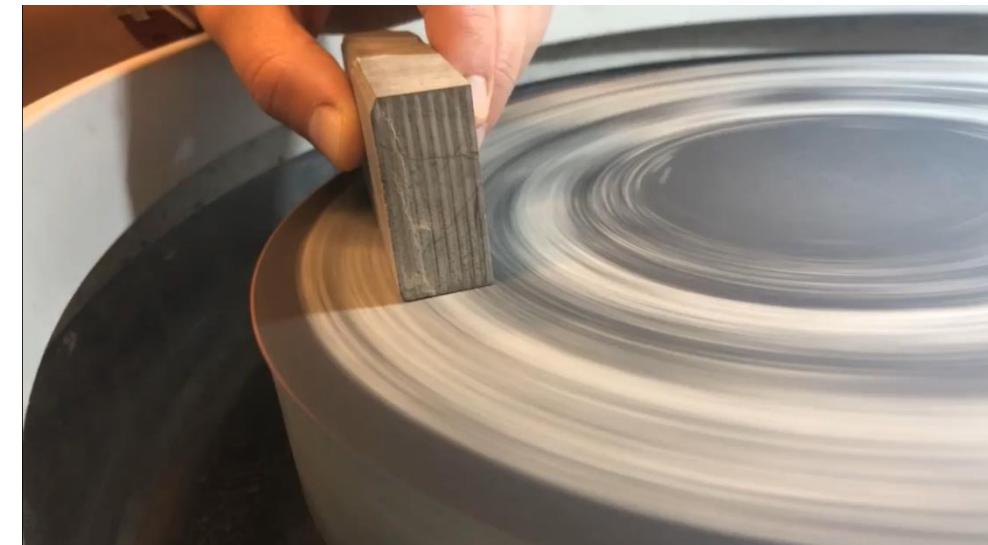
Préparation des échantillons

- Ouvrir et découper les blocs dans les carotte cylindrique fournit par l'ANDRA
- Polir les surfaces qui seront analysé par correlation d'images
- Polir les surfaces cisaillées
