Flood Risk Management – Multi layer strategy

REAL[®] Rapid Engineering Assessment of Levees

Dike ring 10 'Mastenbroek', NL

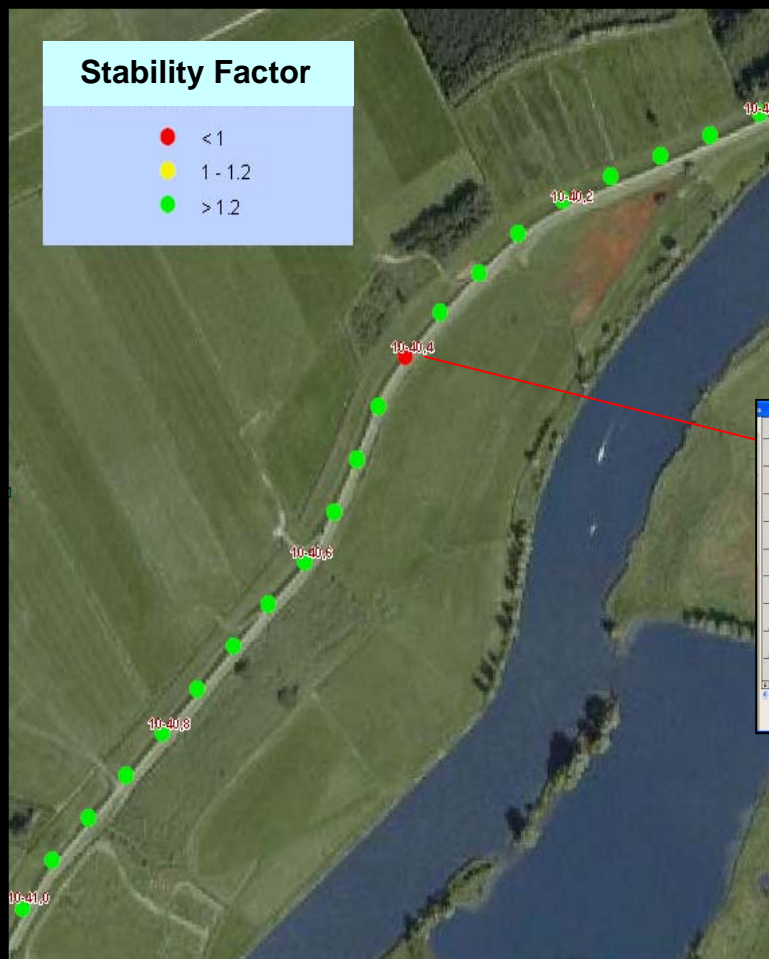
Slope Stability / Fixed water level

SLOPE STABILITY

Automated MStab Slope Stability Calculations

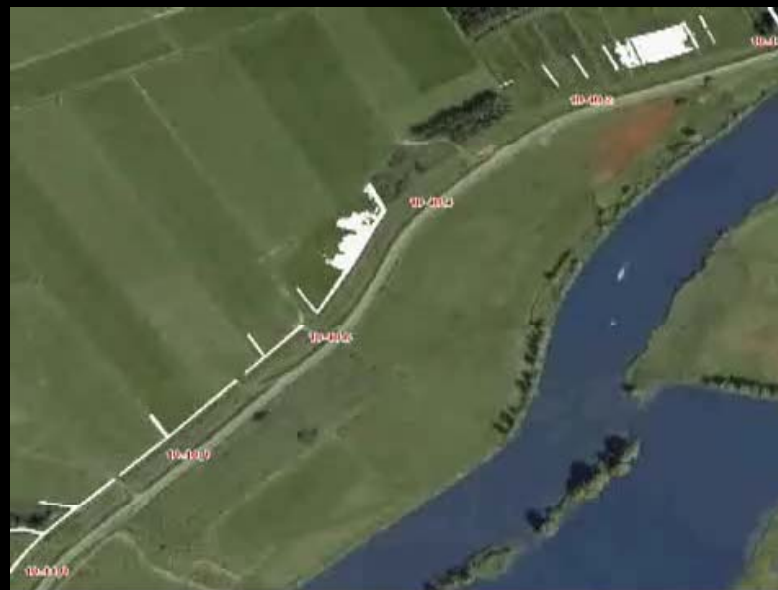
Uplift & Piping / Rising water level

UPLIFT

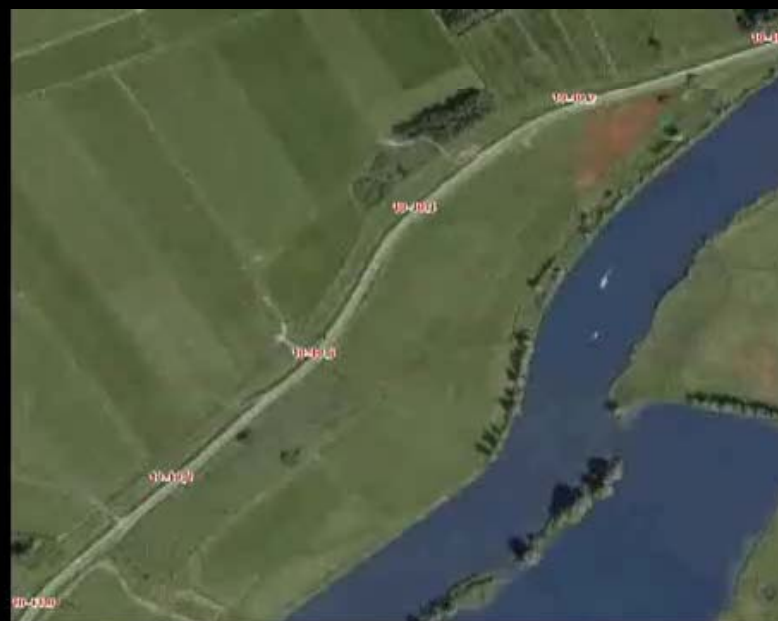
PIPING

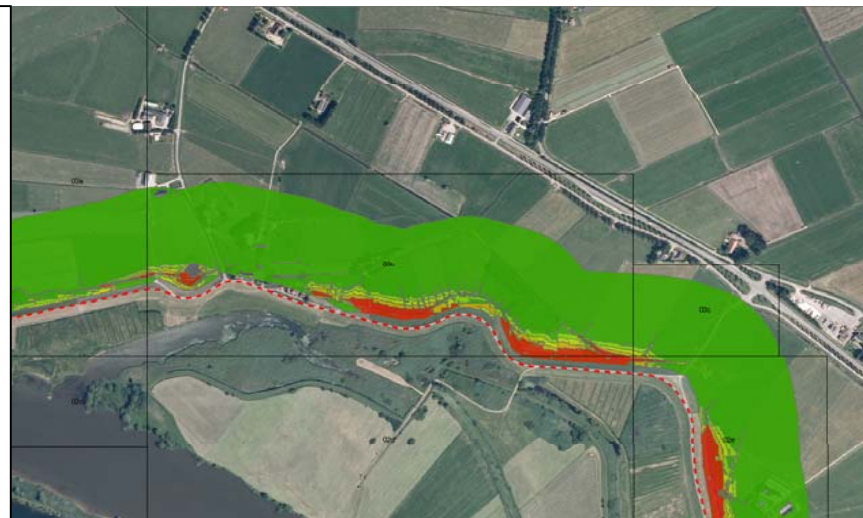
Worst case

1 / 10,000 water level	+0.3m
Thickness cover layer margin	-0.5m
Creep factor Bligh	21
Response factor groundwater	1.0
Seepage length margin	-5m

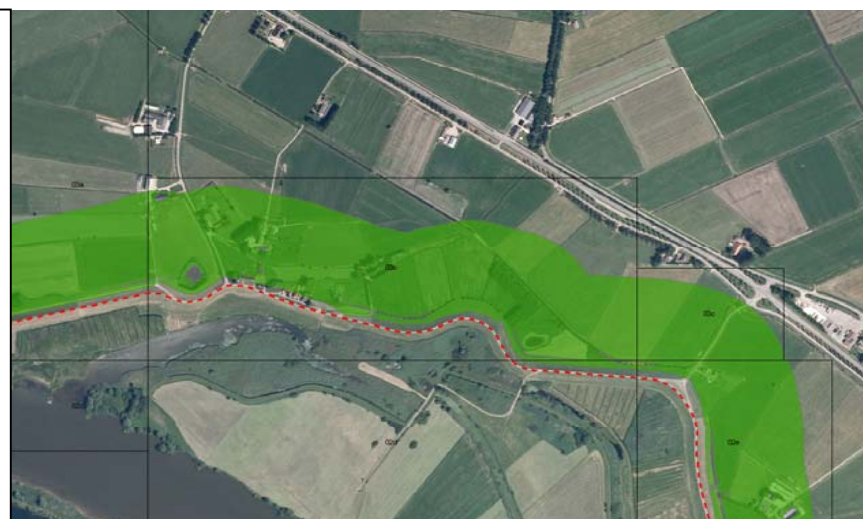
Best case

1 / 2,000 water level	0
Thickness cover layer margin	+0.5m
Creep factor Bligh	15
Response factor groundwater	0.6
Seepage length margin	+5m

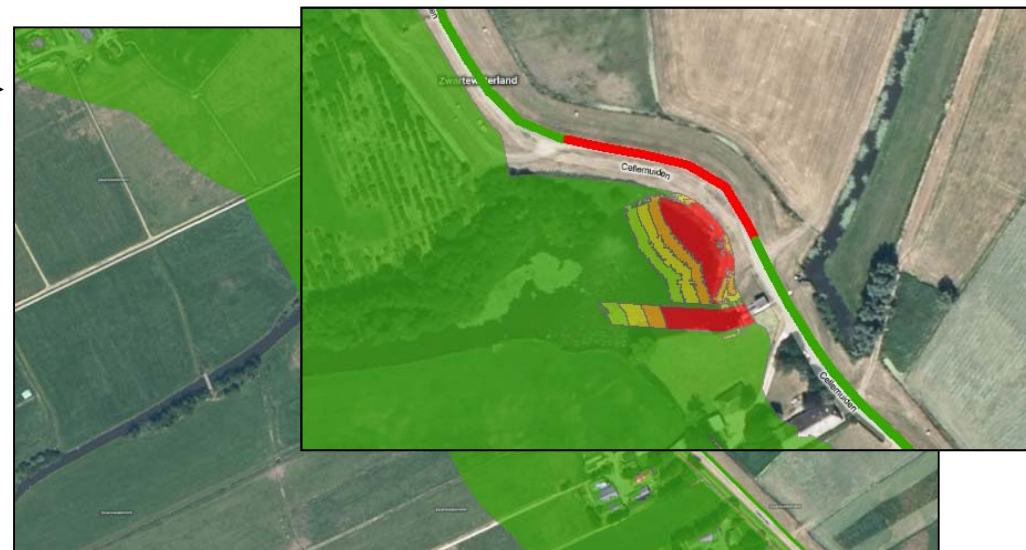
Piping / Fixed water level / Safety Report

1/2,000 water level	0
Thickness cover layer margin	0
Creep factor Bligh	15
Response factor groundwater	0.7
Seepage length margin	0
